**Flood Control Project Maintenance  
Levee Inspections**

**Fall 2016 Levee Maintenance Deficiency Summary Report**

**Sutter Maintenance Yard Nelson Bend**

Waterway	Bank	Unit Miles	Inspection Start/End	Inspector
Unit No. 01 Feather River West Levee - Nelson Bend		0.50	09/28/2016 09/28/2016	Sterling York

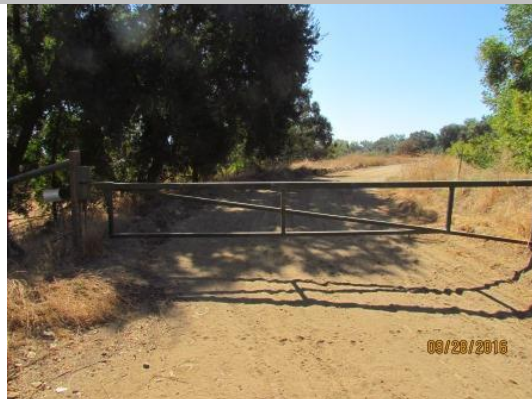
Photo 1 of 1 : FA\_2016\_ST0006\_471\_7\_20160928\_00006.jpg

LM Start	0.01	Rating **	U	Issue No.	7
LM End	0.04	Issue Type +	En	Location *	CR
Category	Earthen Levee			GPS Latitude/Longitude	
				Start	End
Item	Encroachments			38.887006 °	38.886591 °
				-121.614735 °	-121.614956 °
DWR ID	DWR_ST0006_01_f_2012_7

Comment Code					
FE : Fence					
Inspector Comment					
A landowner has constructed a gate on the crown that hinders inspection of this unit. The unit was inaccessible for the fall 2012 season and was not inspected. The unit was accessible during the spring 2013 inspection, but was difficult to open and should be monitored. Met with landowner to perform spring 2015 inspection, and he should be contacted to open the gate for future inspections. The land owner is David Lowry his phone number is (925) 606-2403. He will open the gate for inspections but will not allow the LMA to put a lock on the gate, and the LMA does not do any maintenance to this levee.

View of fence and gate that only has land owners lock on it beginning of levee looking downstream. Fall 2016.

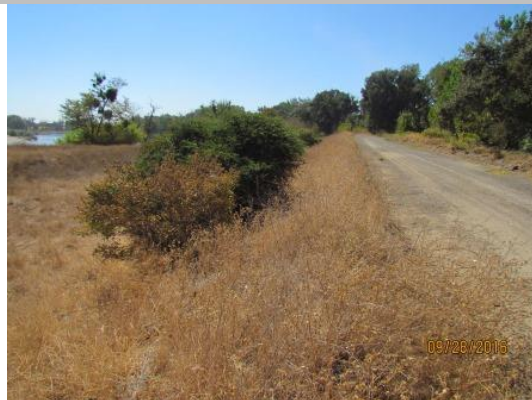
Photo 1 of 1 : FA\_2016\_ST0006\_471\_15\_20160928\_00007.jpg

LM Start	0.02	Rating **	U	Issue No.	15
LM End	0.42	Issue Type +	Ma	Location *	WS
Category	Earthen Levee			GPS Latitude/Longitude	
				Start	End
Item	Vegetation			38.886883 °	38.881287 °
				-121.614797 °	-121.614490 °
DWR ID	DWR_ST0006_01_f_2015_15				
Comment Code					
V2 : Remove the wild growth other than native grasses from the levee slopes.					
Inspector Comment					
Remove the vegetation and trim up the trees 5 feet for visibility.

View of the trees, vegetation and elderberries along the waterside slope looking downstream. Fall 2016.

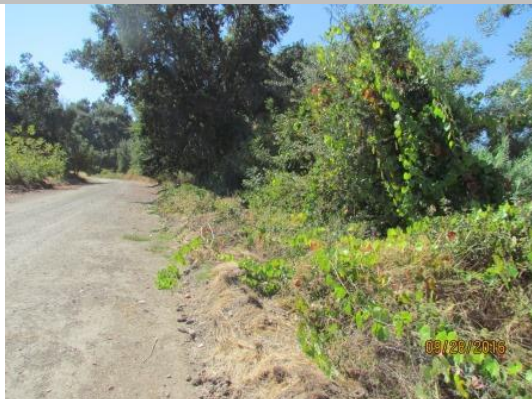
Photo 1 of 1 : FA\_2016\_ST0006\_471\_2\_20160928\_00008.jpg

LM Start	0.02	Rating **	U	Issue No.	2
LM End	0.46	Issue Type +	Ma	Location *	LS
Category	Earthen Levee			GPS Latitude/Longitude	
				Start	End
Item	Vegetation			38.886883 °	38.880833 °
				-121.614797 °	-121.614387 °
DWR ID	DWR_ST0006_01_f_2015_2				
Comment Code					
V2 : Remove the wild growth other than native grasses from the levee slopes.					
Inspector Comment					
Remove the vegetation, wild growth, and trim up the trees 5 feet for visibility.

View of the vegetation, wild growth, trees, and elderberries along the landside slope looking downstream. Fall 2016.

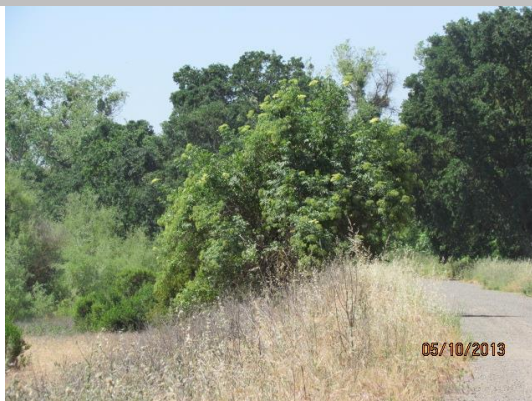
Photo 1 of 1 : FA\_2016\_ST0006\_471\_4\_20160906\_00002.jpg

LM Start	0.06	Rating **	M	Issue No.	4	
LM End	0.06	Issue Type +	Ma	Location *	WS	
Category	Earthen Levee			GPS Latitude/Longitude		
				Start		End
Item	Vegetation			38.886277 °		38.886277 °
				-121.615129 °		-121.615129 °
DWR ID	DWR_ST0006_01_s_2012_4					
Comment Code						
V4 : Elderberries are blocking visibility and flood fight capability.						
Inspector Comment						
Elderberries are partially blocking visibility.

View of the elderberries that are blocking visibility.

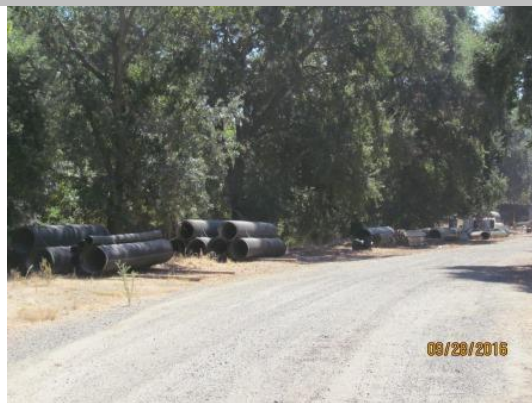
Photo 1 of 1 : FA\_2016\_ST0006\_471\_16\_20160928\_00009.jpg

LM Start	0.40	Rating **	U	Issue No.	16
LM End	0.46	Issue Type +	En	Location *	WS
Category	Earthen Levee			GPS Latitude/Longitude	
				Start	End
Item	Encroachments			38.881638 °	38.880795 °
				-121.614647 °	-121.614427 °
DWR ID	DWR_ST0006_01_f_2015_16				
Comment Code					
DE : Debris					
Inspector Comment					
The large pipe is laying along the waterside berm.

View of the pipe along the waterside berm looking downstream. Fall 2016.

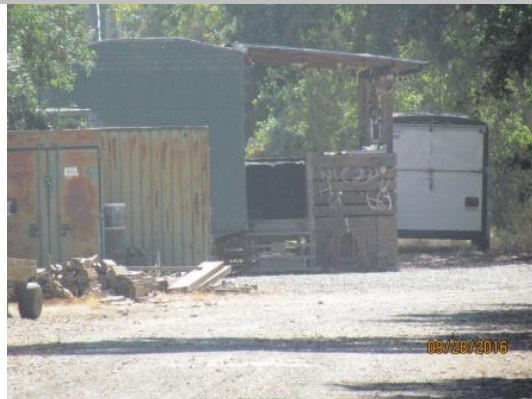
Photo 1 of 1 : FA\_2016\_ST0006\_471\_8\_20160928\_00010.jpg

LM Start	0.47	Rating **	U	Issue No.	8	
LM End	0.47	Issue Type +	En	Location *	CR	
Category	Earthen Levee			GPS Latitude/Longitude		
				Start		End
Item	Encroachments			38.880664 °		38.880664 °
				-121.614335 °		-121.614335 °
DWR ID	DWR_ST0006_01_s _ 2012_8					
Comment Code						
BU : Building						
Inspector Comment						
The building is directly behind the pipe that is laying along the waterside berm.

View of the building directly behind the pipe on the waterside berm looking downstream. Fall 2016.
